SECTION 3

CHANGES TO THE BUILDING EXTERIOR

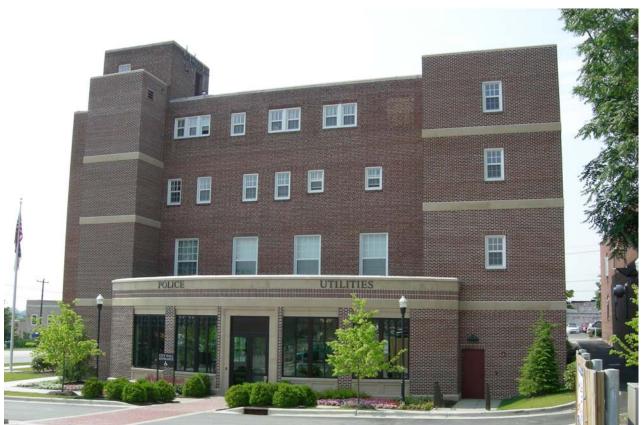
A recent City Hall rehabilitation project, which was completed in 2005, included a major addition to the rear of the building along Sixth Avenue East.
